**Flood Control Project Maintenance  
Levee Inspections**

**Fall 2012 Levee Maintenance Deficiency Summary Report**

**Reclamation District No. 2107 Mossdale Island**

**Levee Inspection Report By Mile - Fall 2012**

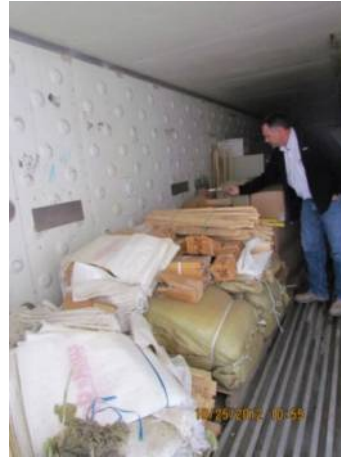
Levee Mile Report Line	1
Start Levee Mile	
End Levee Mile	
Location	Water Side
Category	Earthen Levee
Item	Emergency Supplies & Equipment
View of flood fight supplies stored in weather proof container.	
mkhashch_f_20121105_719.JPG

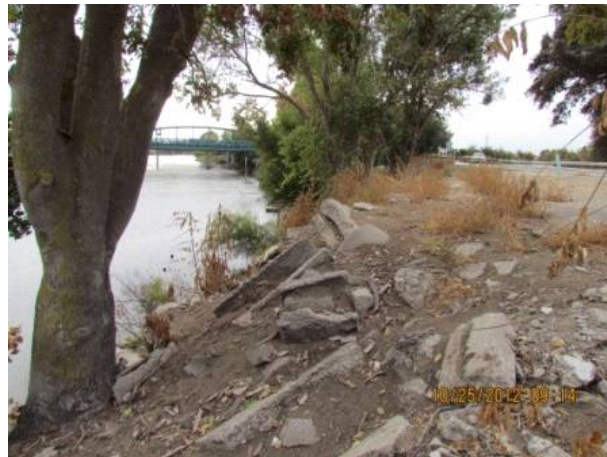
Levee Mile Report Line	4
Start Levee Mile	0.03
End Levee Mile	0.03
Location	Water Side
Category	Earthen Levee
Item	Trim / Thin Trees
Photo of waterside slope. Stumps present from prior tree removal for access and visibility.	
mkhashch_f_20121105_718.JPG

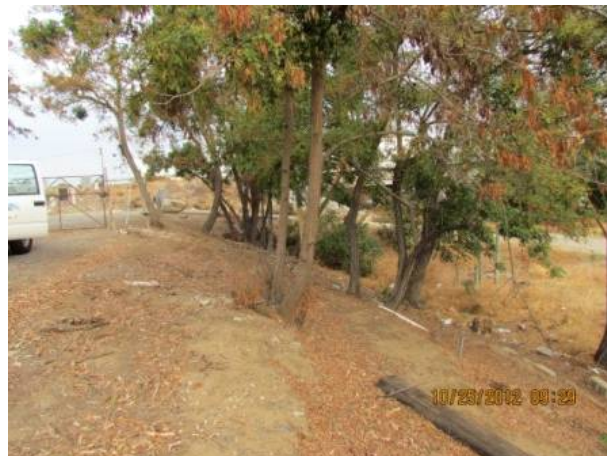
Levee Mile Report Line	5
Start Levee Mile	0.25
End Levee Mile	0.25
Location	Water Side
Category	Earthen Levee
Item	Trim / Thin Trees
Tree stumps present on slope. They were left from prior vegetation removal for access and visibility.	
mkhashch_f_20121105_720.JPG

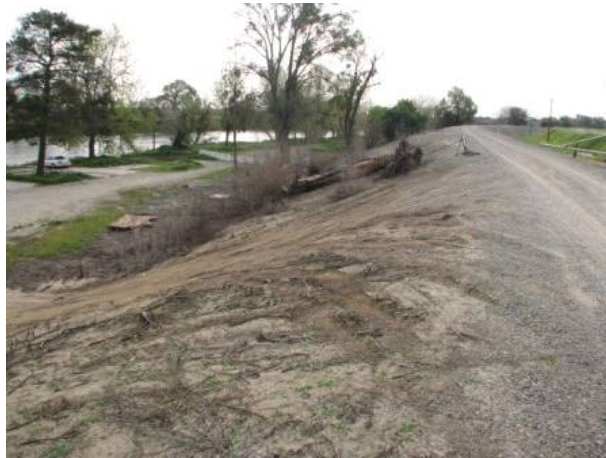
Levee Mile Report Line	6
Start Levee Mile	0.37
End Levee Mile	0.37
Location	Water Side
Category	Earthen Levee
Item	Trim / Thin Trees

Tree stumps and trunks on levee slope. Vehicle traffic on levee slope is an ongoing problem at this location due to the abandoned trailer park, access should be restricted.

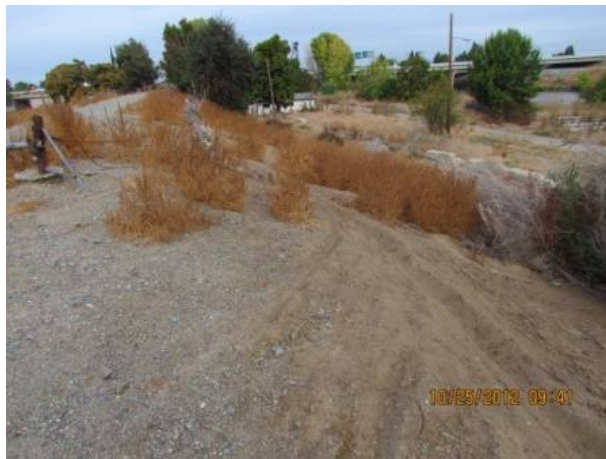
Levee Mile Report Line	7
Start Levee Mile	0.37
End Levee Mile	0.37
Location	Water Side
Category	Earthen Levee
Item	Slope Stability

View of vehicle ruts in waterside slope around the gate on levee crown.

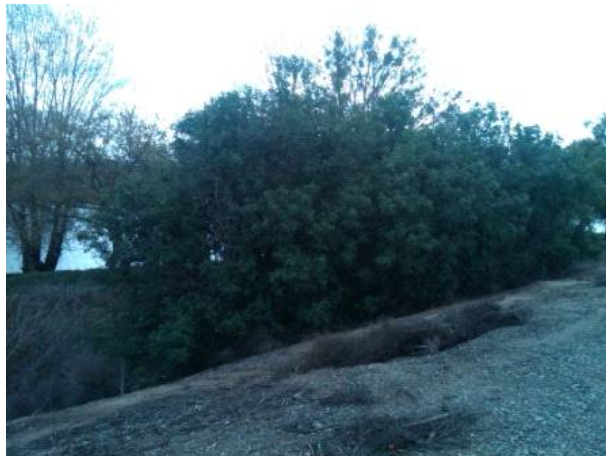
Levee Mile Report Line	8
Start Levee Mile	0.42
End Levee Mile	0.42
Location	Water Side
Category	Earthen Levee
Item	Vegetation

03/26/2012 Large elderberry located on water side slope.

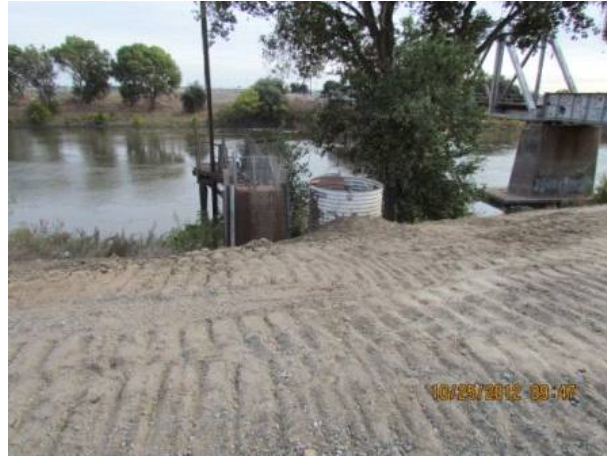
Levee Mile Report Line	9
Start Levee Mile	0.68
End Levee Mile	0.68
Location	Crown
Category	Earthen Levee
Item	Encroachments

Irrigation intake pipe runs through the base of the levee. Stand pipes on waterside and landside. A butterfly valve is located near waterside slope.

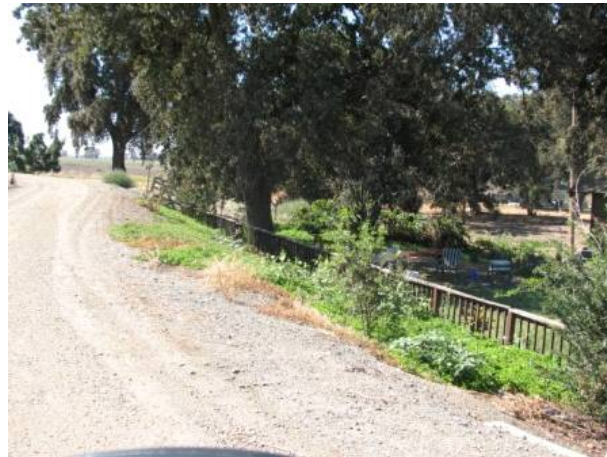
Levee Mile Report Line	11
Start Levee Mile	1.24
End Levee Mile	1.24
Location	Land Side
Category	Earthen Levee
Item	Vegetation

Fall 2009 photo of landscape planting on landside levee slope and a 3-ft yard fence at the levee toe.

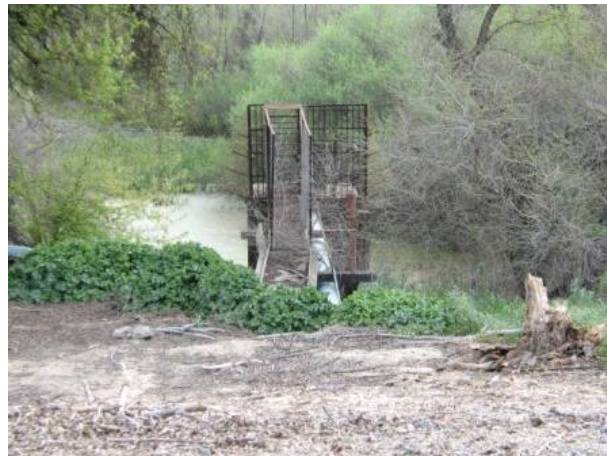
Levee Mile Report Line	12
Start Levee Mile	1.49
End Levee Mile	1.49
Location	Crown
Category	Earthen Levee
Item	Encroachments

Irrigation intake pipe through levee freeboard.

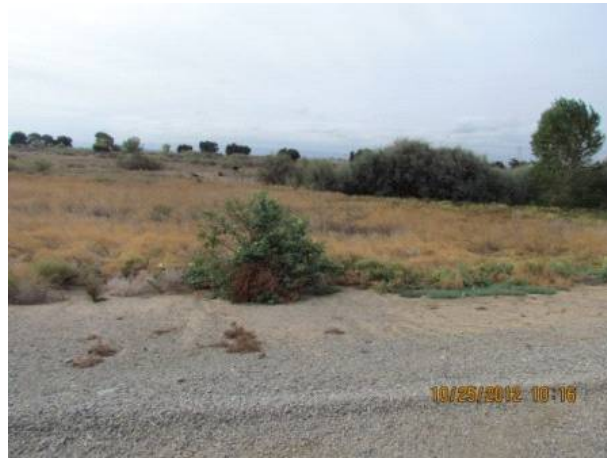
Levee Mile Report Line	1
Start Levee Mile	0.50
End Levee Mile	0.50
Location	Water Side
Category	Earthen Levee
Item	Vegetation

Elderberry located on water side slope.

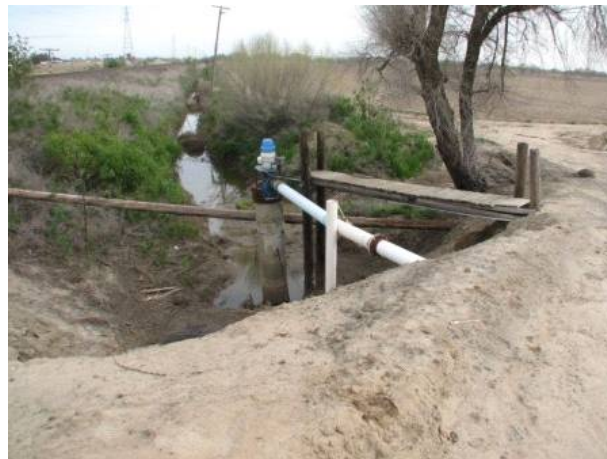
Levee Mile Report Line	2
Start Levee Mile	0.55
End Levee Mile	0.55
Location	Crown
Category	Earthen Levee
Item	Encroachments

Drainage discharge pump. Steel pipe penetrates levee freeboard. No flapgate on waterside. No closure device.

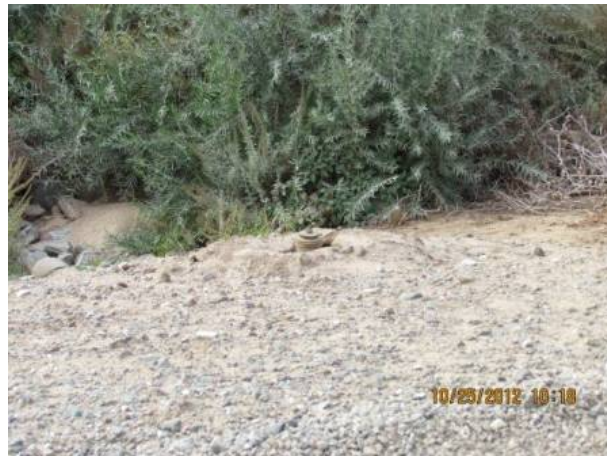
Levee Mile Report Line	2
Start Levee Mile	0.55
End Levee Mile	0.55
Location	Crown
Category	Earthen Levee
Item	Encroachments

View of siphon breaker causing some erosion on slope.

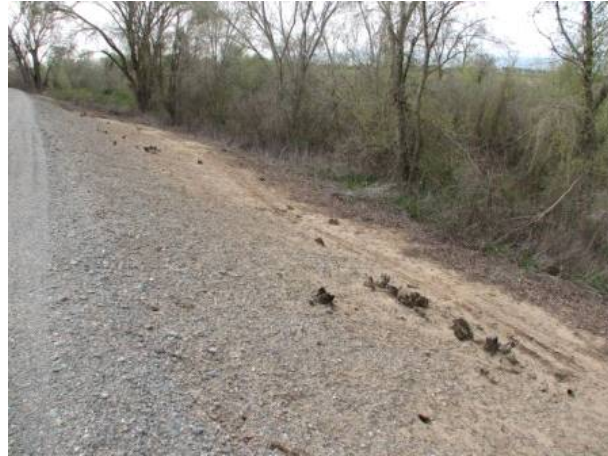
Levee Mile Report Line	3
Start Levee Mile	0.84
End Levee Mile	0.84
Location	Water Side
Category	Earthen Levee
Item	Trim / Thin Trees

Tree stumps on levee slope.

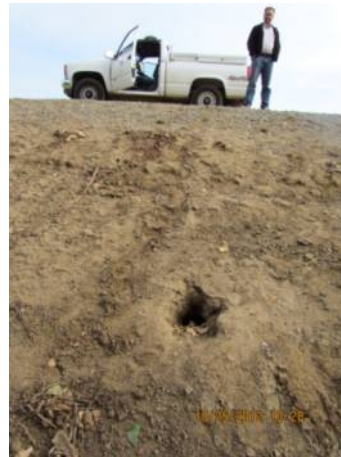
Levee Mile Report Line	4
Start Levee Mile	1.06
End Levee Mile	1.06
Location	Water Side
Category	Earthen Levee
Item	Animal Control

View of large burrow on waterside slope.

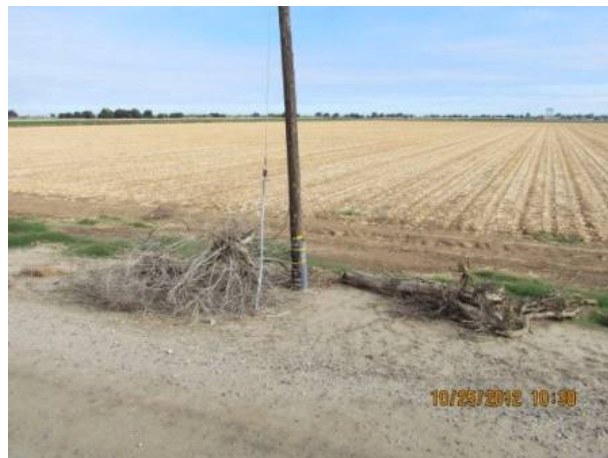
Levee Mile Report Line	5
Start Levee Mile	1.39
End Levee Mile	1.39
Location	Land Side
Category	Earthen Levee
Item	Encroachments

View of prunings at landside toe.

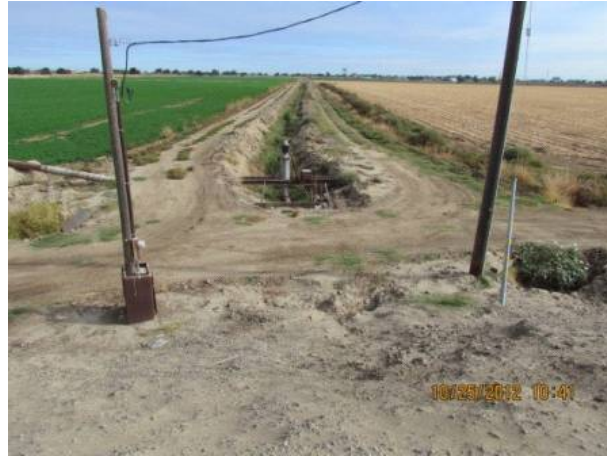
Levee Mile Report Line	6
Start Levee Mile	1.54
End Levee Mile	1.54
Location	Land Side
Category	Earthen Levee
Item	Encroachments

View of irrigation pipe and canal.
